COMPARISON REPORT for vessel of less than 15m Length Overall

Part 1 - Vessel and Owner Details

Date & Location of Survey

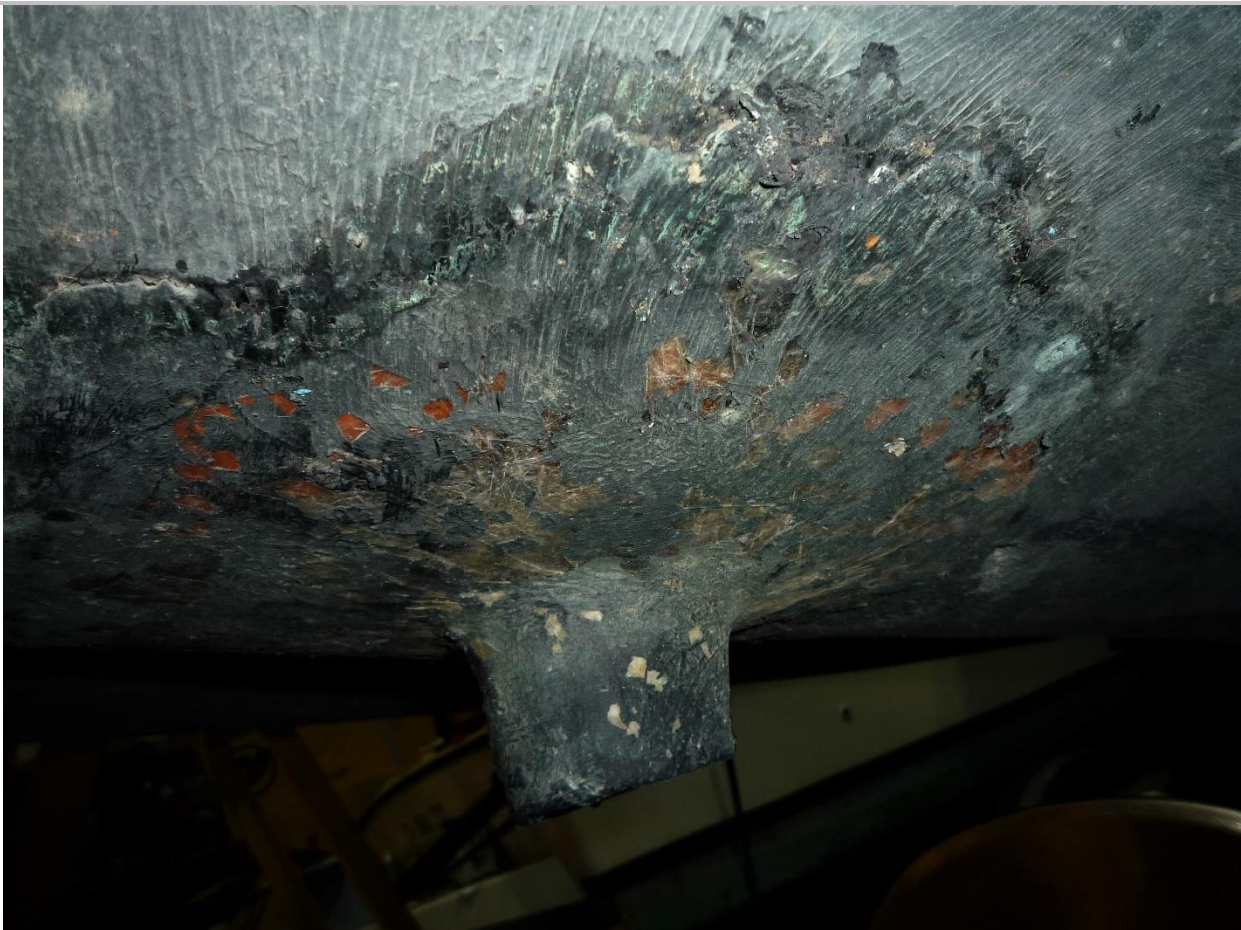
This photograph shows the failing laminates around the external rudder tube location

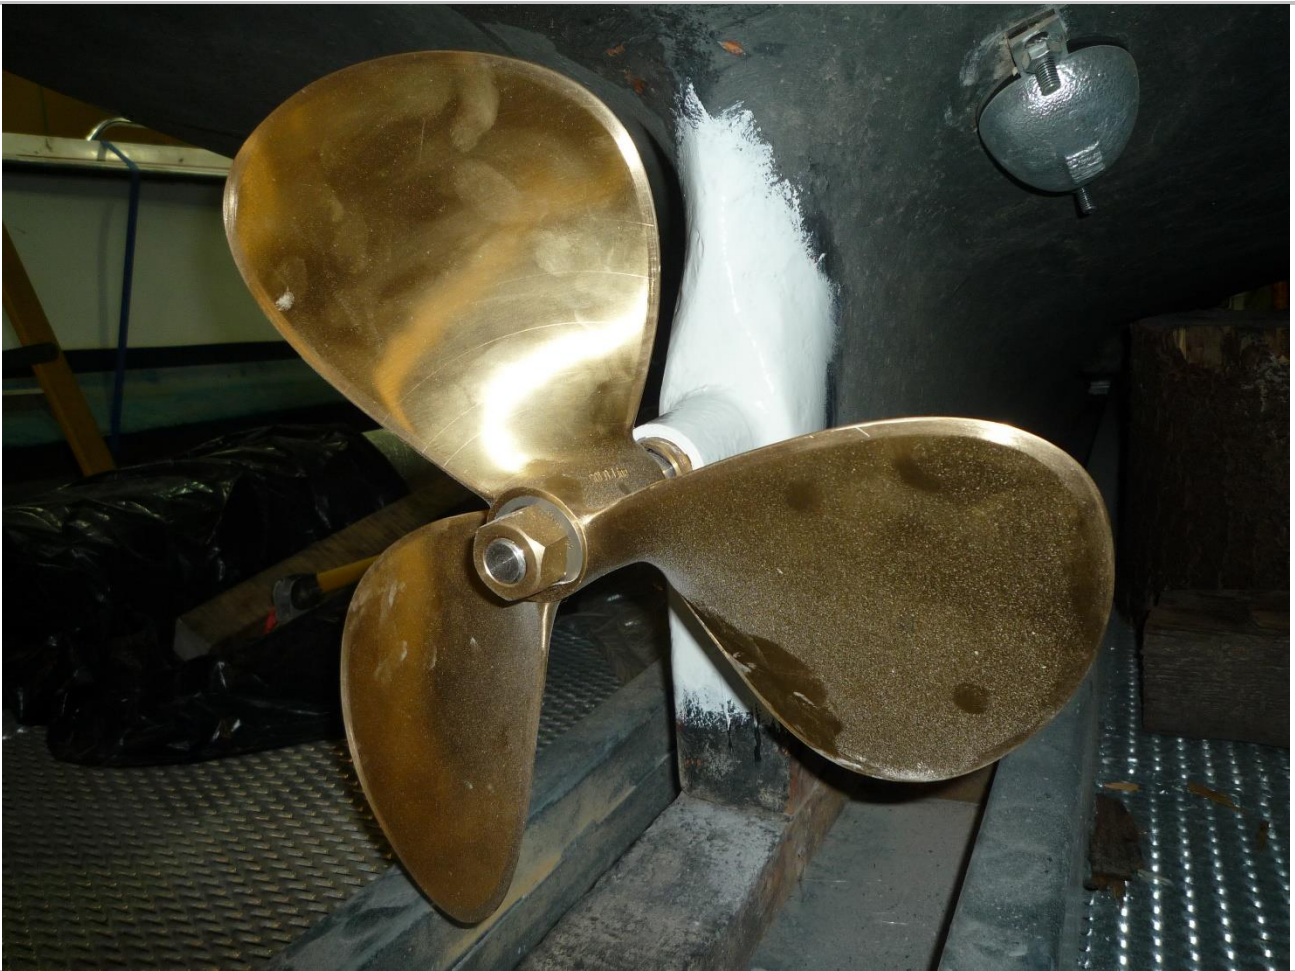
New bronze propeller and new anode can just be seen top right hand. The propeller nut is locked.

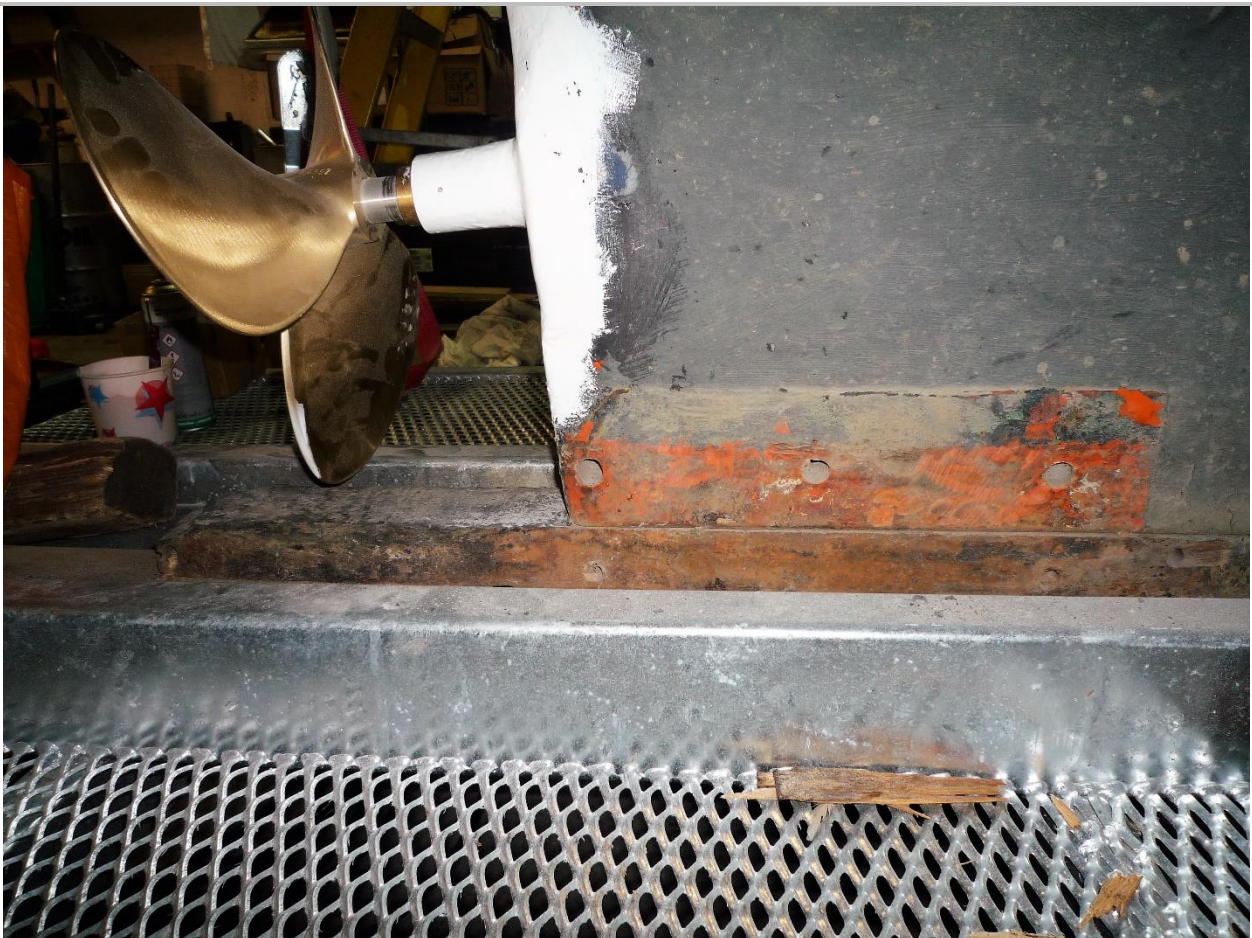
The keel extension supporting the bottom end of the rudder was not available for inspection and has not been fitted yet

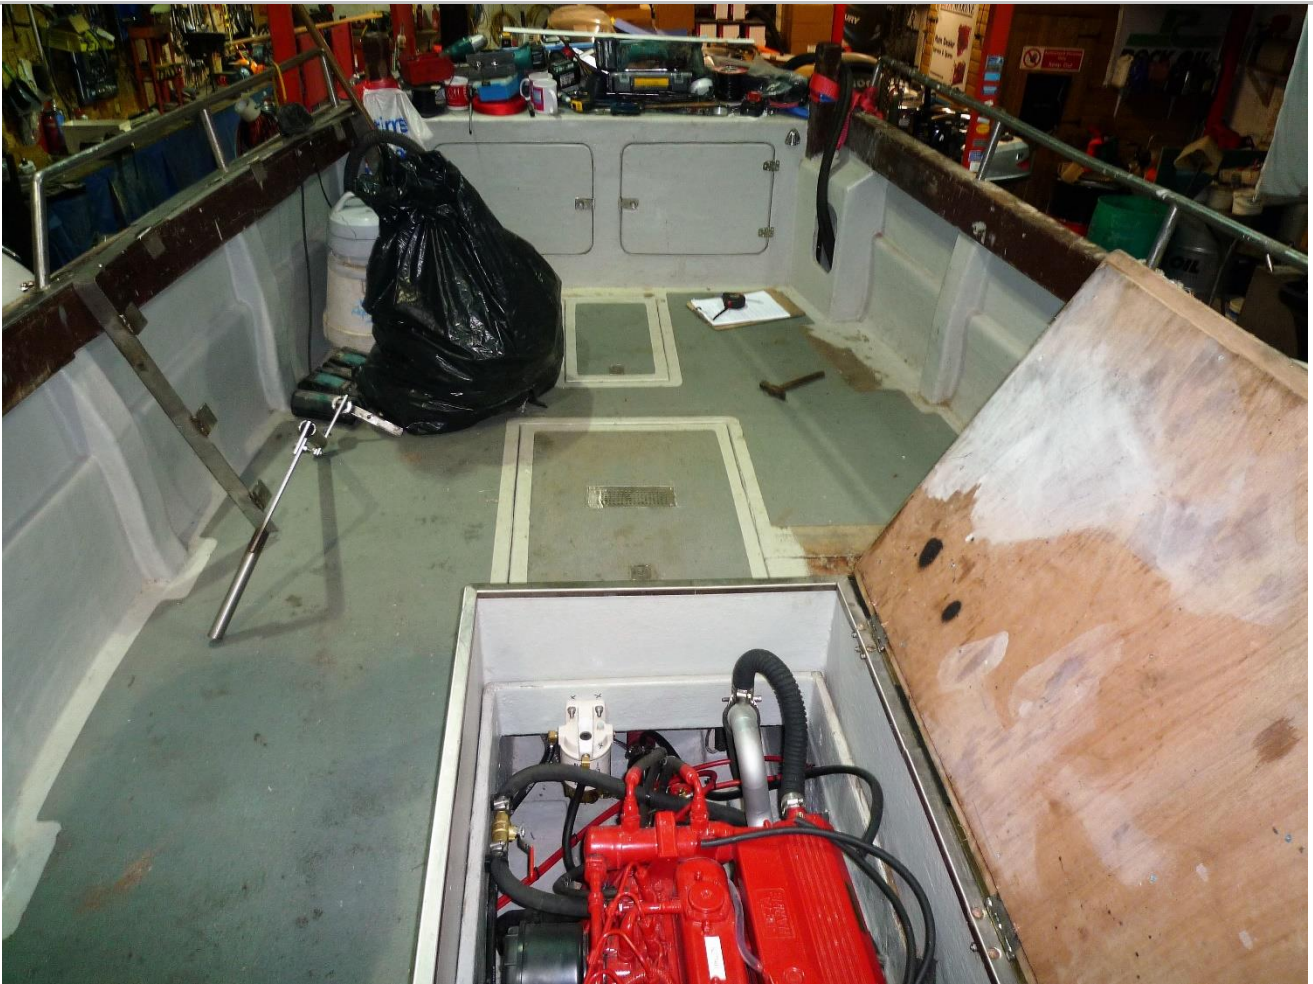
4.5	Are they weathertight? Yes
4.6	Are they operable from both sides (escapes only)? N/A
	Comments – The two aft deck hatches are not fitted with any retaining lanyards.

Deck layout. The batteries are stored in the locker that can be seen at the transom. The two hatches on the deck are not fitted with any retaining lanyards

4.7	Actions required to meet Seafish Construction Standards – Both aft hatches must be fitted with retaining lanyards to avoid the loss of the hatch. Hatch not to be opened at sea notice to be a fixed close to the hatches. This will be mainly for crew safety as, this is an open vessel and any water taken aboard would have to drain into the bilges anyway.
5	Standards Sections 3.2 & 9.2 - Air pipes

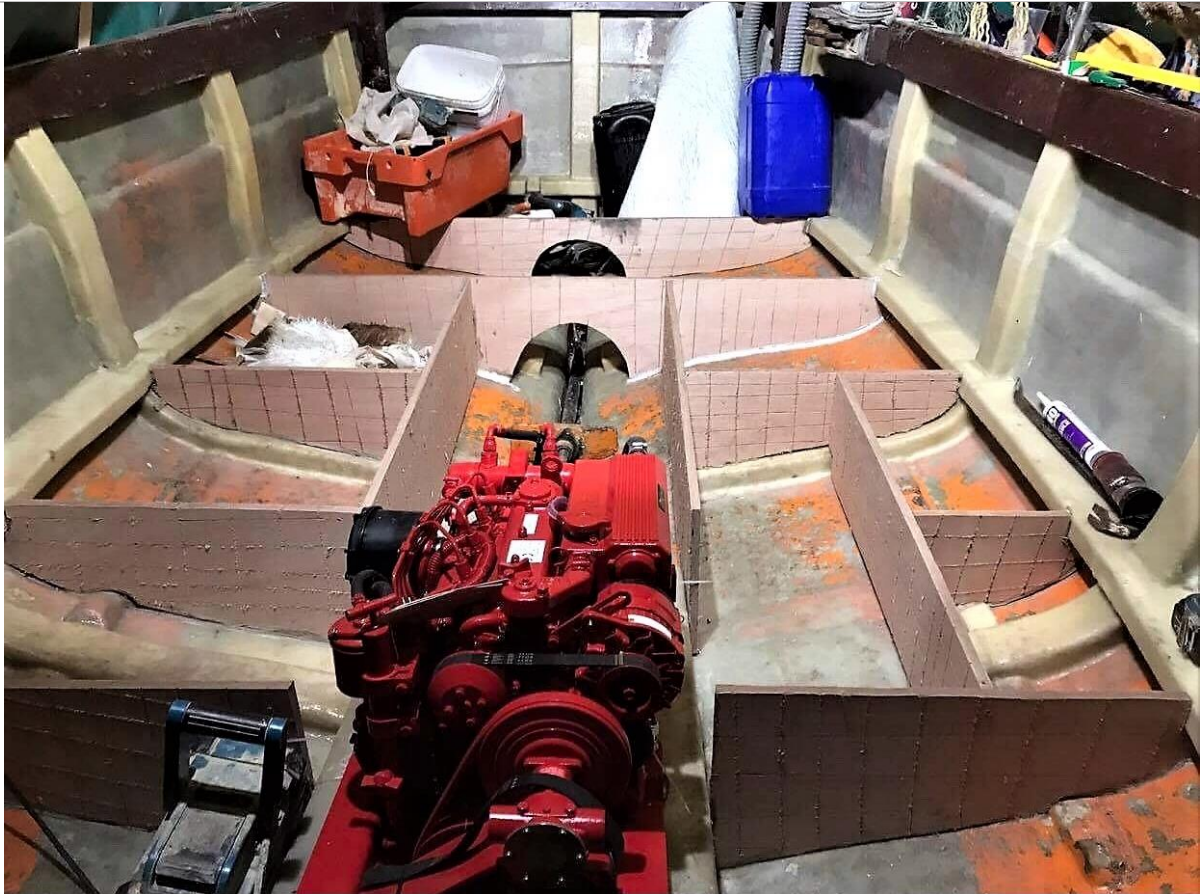
Applicant supplied photo of the deck construction in build. From this it would appear that the individual compartments are probably less than 1 cu.mtr. No major athwartships floors but considerable stiffening in the lower bilges

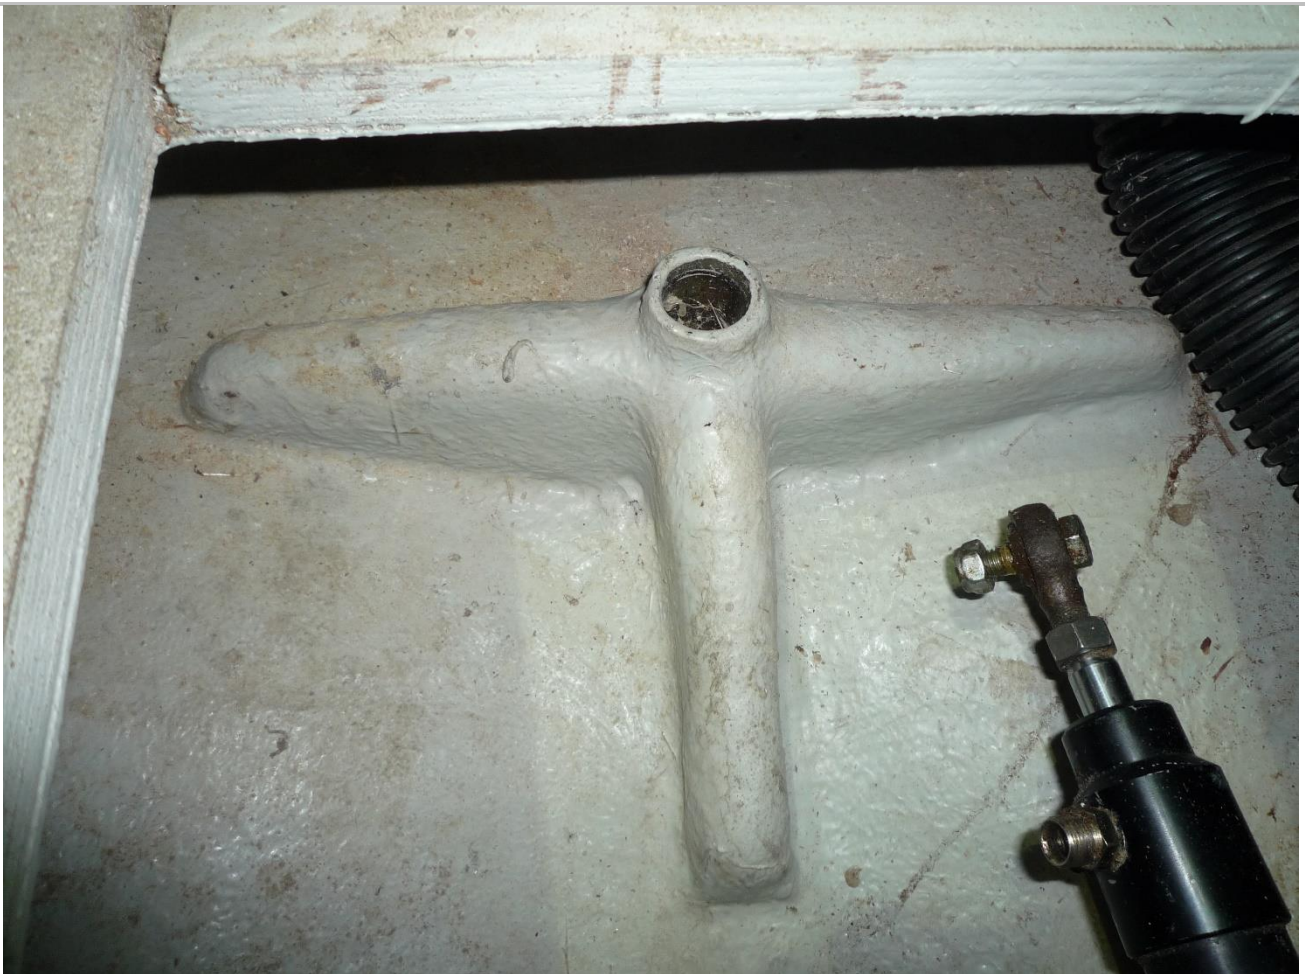
15.5	Are bypass valves fitted in the remote system to relieve pressure for emergency gear? Yes
	<p>Comments – At the time of this inspection the rudder and rudder stock were not in position and could not be located because it was not possible to increase the height of the vessel in order locate the rudder and stock into the rudder tube. The hydraulic steering has not yet been fully connected although there is a bypass valve awaiting finalising Therefore it has not been possible to comment on most of the inquiries above.</p> <p>The top of the rudder tube is noticeably lower than the waterline and, although the applicant informs me that the rudder stock is fitted with O rings I do not believe this will be adequate with regard to watertight integrity.</p>

Limited height rudder tube exit, needs raising.

15.6	<p>Actions required to meet Seafish Construction Standards – The steering gear will have to be fully installed and in operating condition in all aspects before registration acceptance.</p> <p>The fact that the bonded rudder tube top is below the waterline level is a concern and this should be attended to. It is anticipated that it will be possible to fit a rubber gaiter (not too dissimilar to that used on the propeller shaft gland housing) to increase the height overall bringing it above the waterline.</p> <p>Emergency steering fabrication was seen this is stainless steel and looks likely to be appropriate but could not be tested..This will require to be seen to be appropriate when the steering is completed.</p>
16	Standards Section 9 - Piping

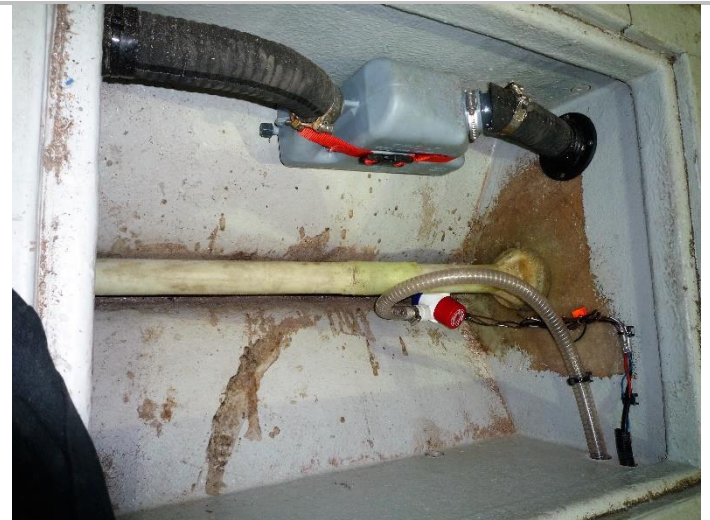
New grp propeller shaft tube and non secured electric bilge pump. This area is awaiting additional ballast before the pump is finally located. The unsupported length of prop shaft just falls within the acceptable maximum length.

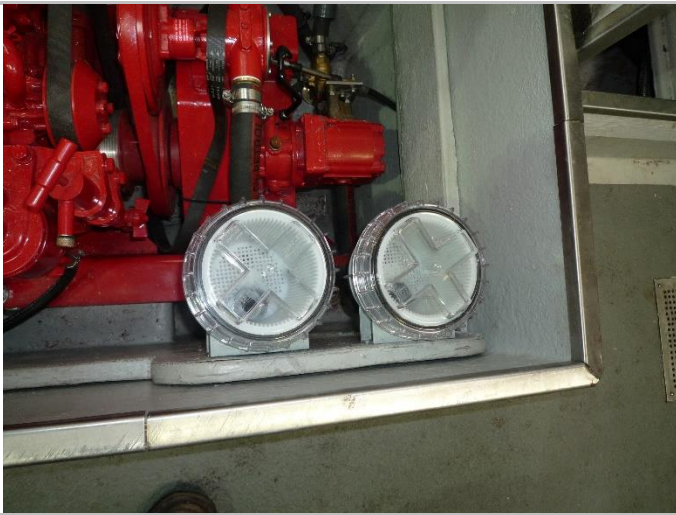
14.10	Is the minimum equipment and instruments listed in sections 8.1.11 and 8.1.12 found onboard the vessel? Yes
	Comments – The water strainers fitted for the engine and the deck wash pump do not appear to be an approved types as they have plastic tops with, what appears to be plastic bodies These are new VETUS units..

Engine water strainers. These are new. It is likely these are not approved strainers.

14.11	Actions required to meet Seafish Construction Standards – The standards are not specific on the fitting of these strainers as they are not specifically approved items. Approved strainers will possibly be required by the Authority

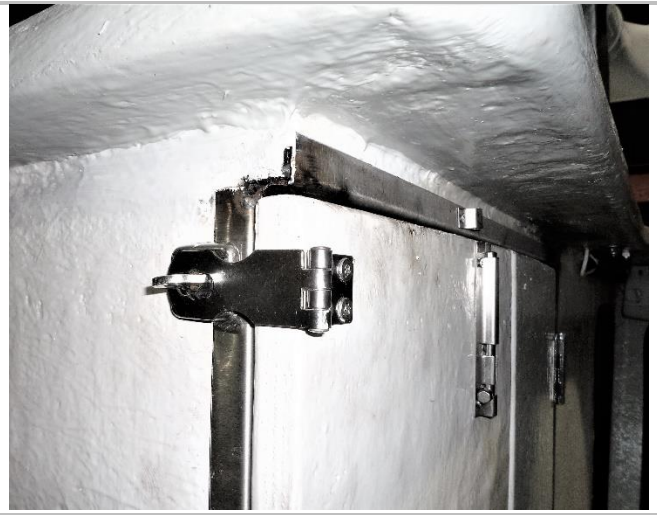
The latch on the wheelhouse door that can automatically secure the door closed if personnel are within the wheelhouse if the door is closed abruptly. It then cannot be opened from the inside.

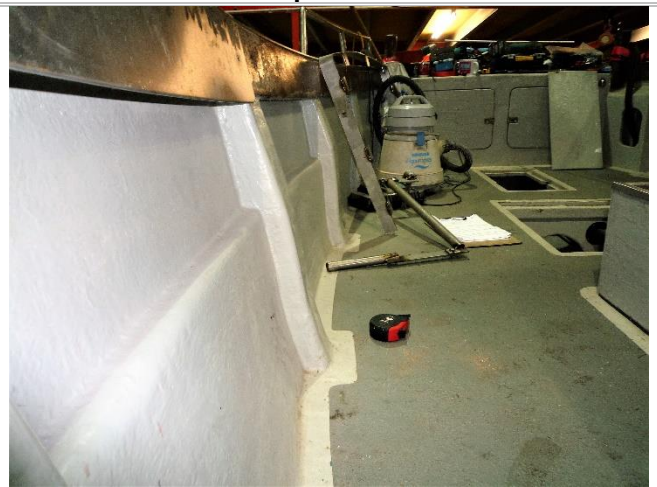
Transverse hull framing	Substantial frames 100mm x 50mm @ 820mm spacing. This is the minimum size however the frames increase in moulded depth considerably at the top of the frame	20 Scantling Frame sections of 70 mm x 60mm are required at spacings of 900 mm. The weight of these should be 1500 gm sq.mtr.	The frames do not match the precise required standard however, it is not considered there is any noticeable loss of strength or rigidity.

Looking aft stbd. side & run of frames. The frame measurement given is the minimum size as seen here

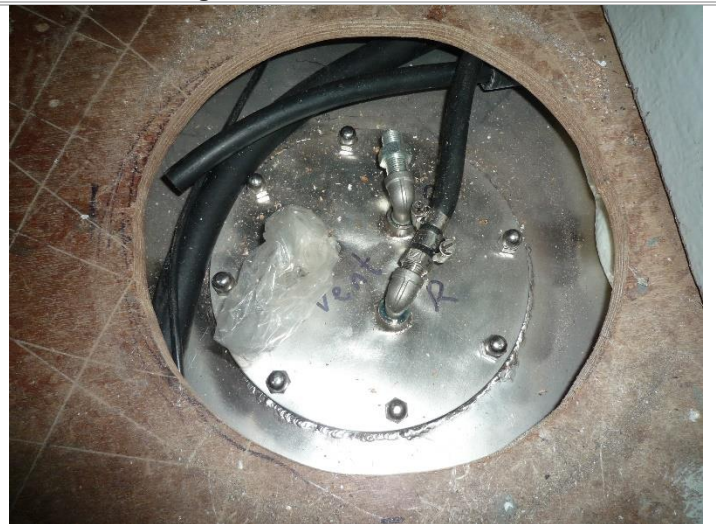
17.6	Are closing appliances fitted to the filler as per the requirements? No
17.7	Are levelling pipes fitted with shut off valves located at each tank side? N/A
	Comments – A new stainless steel tank of approximately 88 litres is fitted. The installation of this is not fully completed with regard to fuel pipe connections and shut off valve installation. The tank is direct fill on top of the tank accessible by a removable hatch that will be installed in the weather deck at this point. Any overspill of fuel will find its way into the bilges as there is no save all fitted on the tank filler neck area

Fuel tank not yet fully connected

17.8	Actions required to meet Seafish Construction Standards – The fuel tank installation requires total completion and some form of saveall must be fitted to the tank filler neck. I believe it will just be possible to design an acceptable solution for this.
18	Standards Section 9.3 - Bilge pumping
